# AIRCRAFT ACCIDENT REPORT

1. On 19 October 1967, WH-07, Bureau Number 151457, was assigned to pilot JACKS and Radar Intercept Officer MACGEARY for a TFQ-10 bombing mission. The aircraft configuration was full internal fuel, two (2) full external wing tanks, two (2) triple ejector racks, one (1) multiple ejector rack and twelve (12) MK-82 500 pound bombs. Sortie was scheduled as a single flight. Gross weight take-off was 53,000 pounds.

VMFA-542 AAR 6-68A, 19 October 1967, F4B BuNo 151457, pilot JACKS

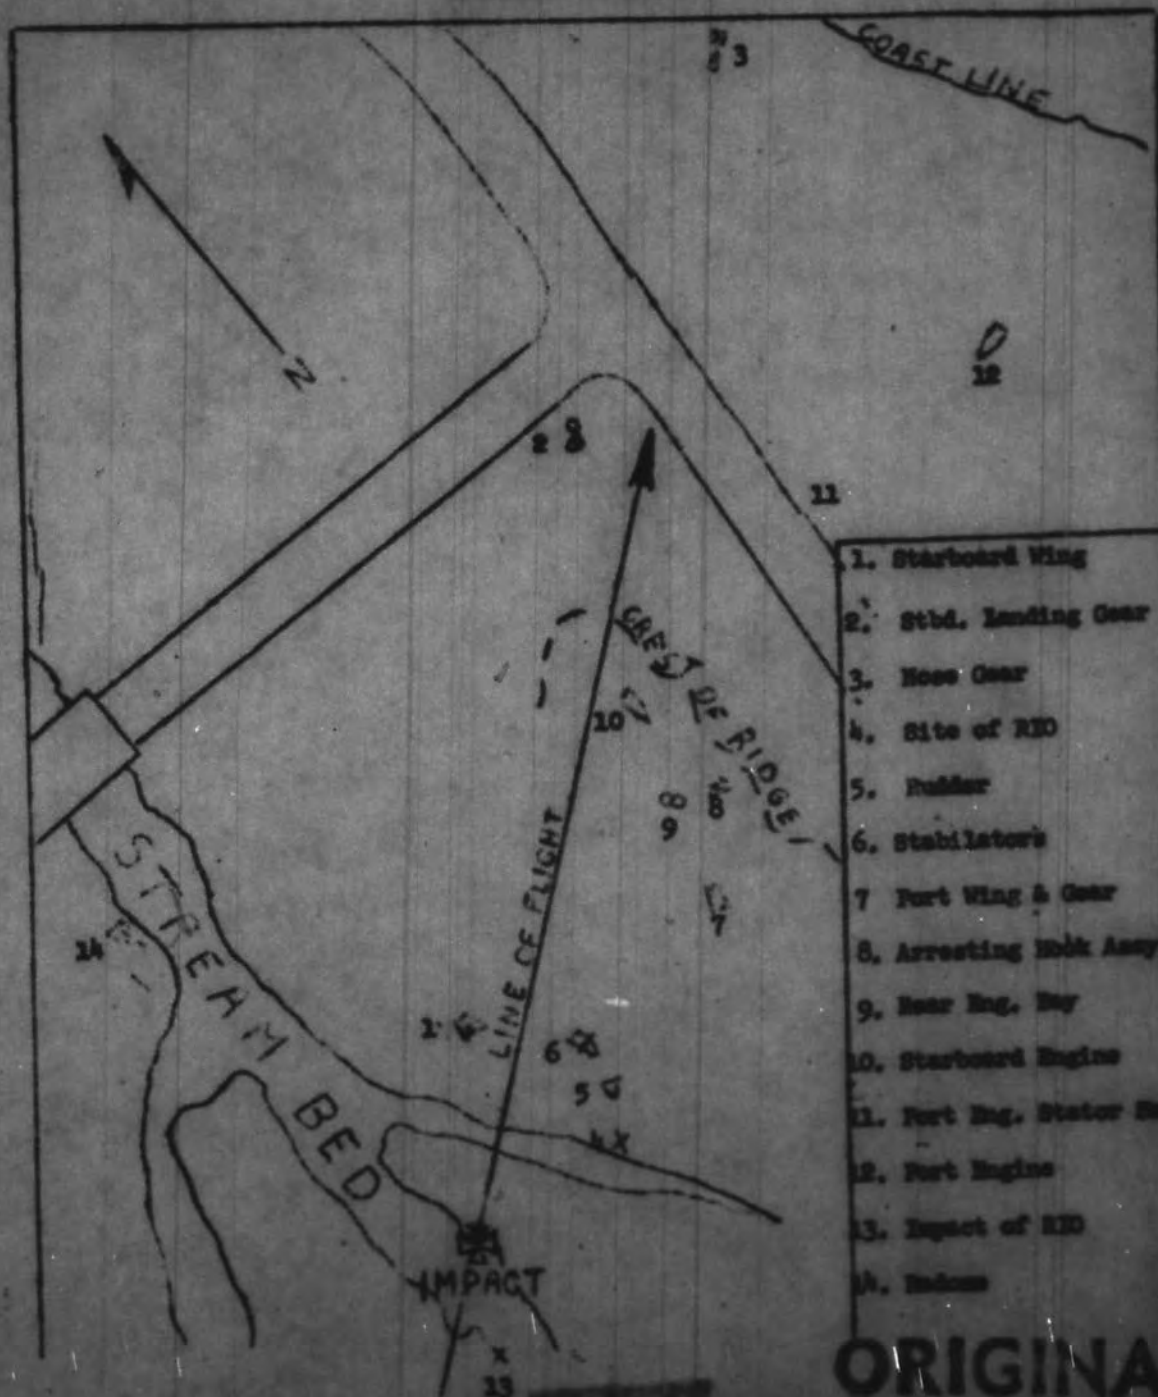
# WRECKAGE DIAGRAM

3. The aircraft separated into seven main sections (Enclosure 13) as it continued to travel over rough sandy terrain and up a slope gradient estimated at 3°. The sections came to rest at the following distances and bearing from initial impact:

- a. Starboard wing - 038° at 90 feet
- b. Stabilator and Rudder - 068° at 121 feet
- c. Port wing - 075° at 256 feet
- d. Port after burner and rear of engine bay - 065° at 283 feet
- e. Aft fuselage structure and arresting hook - 069° at 296 feet
- f. Starboard Engine - 057° at 310 feet
- g. Port Engine - 070° at 672 feet
